KC Realty Inspections

Home Inspection Report

**123 Some Street
Anytown, US 12345**

Inspected on Fri, Mar 24 2017 at 12:45 PM

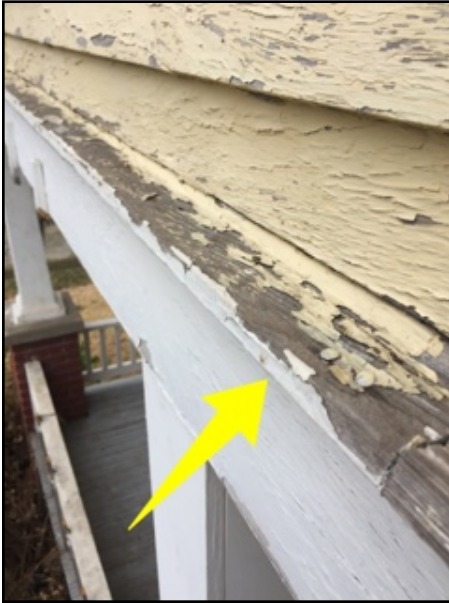
Figure 1-1

Comment 1:
Ledger board above porch needs drip cap.

1) Ledger board above porch needs drip cap.

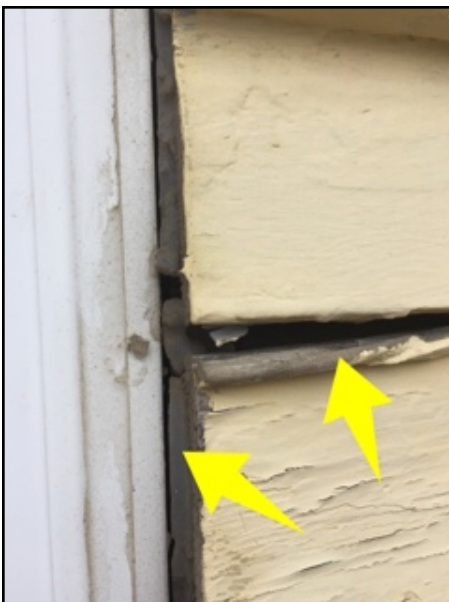
Figure 2-1

Comment 2:
Window and siding around window in front of house needs to be caulked and sealed. Recommend adding additional trim, drip cap and J-channel around and above window

2) Window and siding around window in front of house needs to be caulked and sealed. Recommend adding additional trim, drip cap and J-channel around and above window

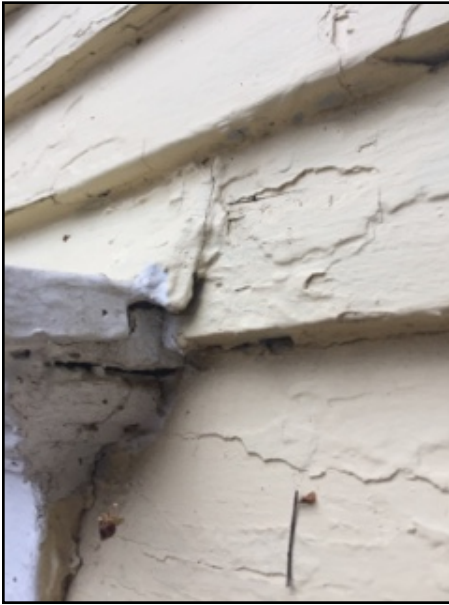
Figure 4-1

Comment 4:
Drip cap above window in back of house should be monitored for bad seal. Drip cap should be behind siding to keep moisture out. Caulk is loose and needs to be replaced.

4) Drip cap above window in back of house should be monitored for bad seal. Drip cap should be behind siding to keep moisture out. Caulk is loose and needs to be replaced.

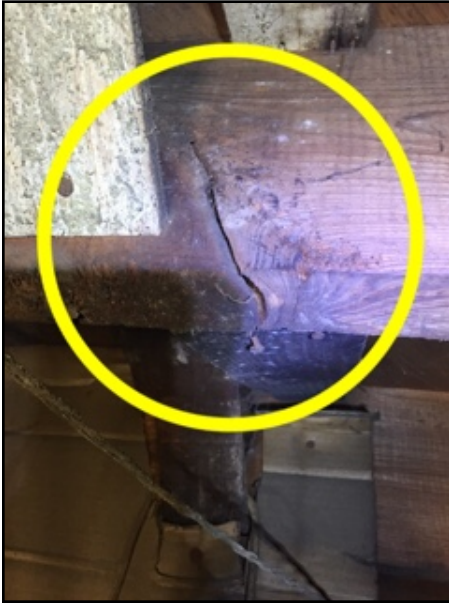
Figure 6-1

Comment 6:
Broken floor joist. Recommend repair by a carpenter

6) Broken floor joist. Recommend repair by a carpenter

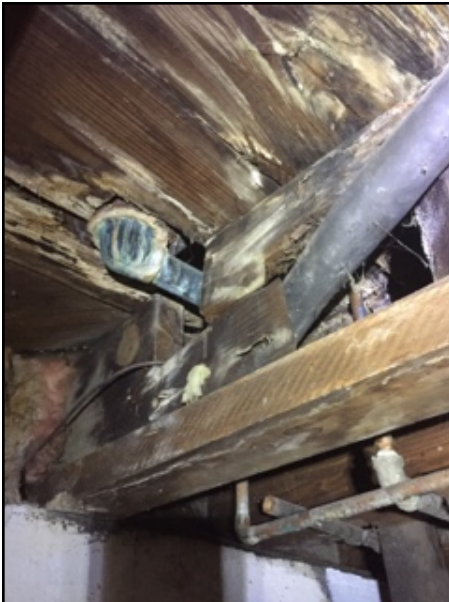
Figure 7-1

Comment 7:
Moisture damaged subfloor below first floor bathroom. Recommend repair by a carpenter.

7) Moisture damaged subfloor below first floor bathroom. Recommend repair by a carpenter.

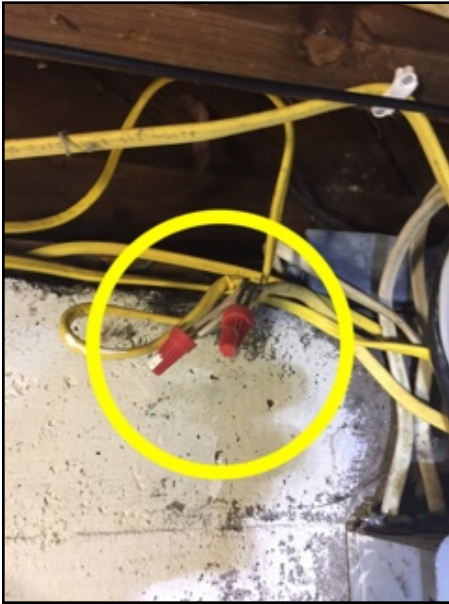
Figure 9-1

Comment 9:
Junction wires need to be enclosed in a junction box

There are multiple double taps in electric panel. Double tapped wiring is dangerous.

There is old knob and tube wiring. Knob and tube wiring is out of date and should be changed.

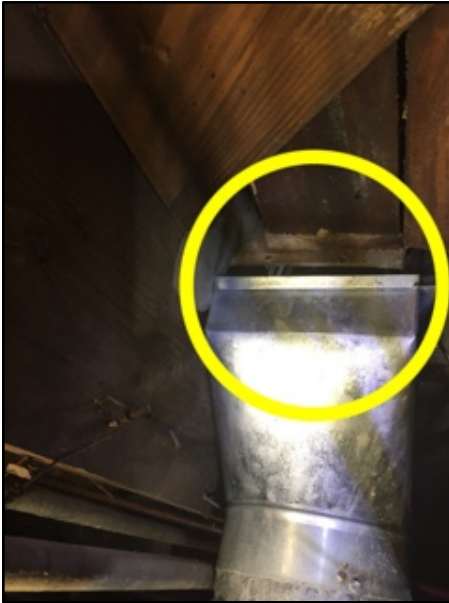
Figure 10-1

Vent not connected properly resulting in heat loss. Recommend securing vent properly

10) Vent not connected properly resulting in heat loss. Recommend securing vent properly

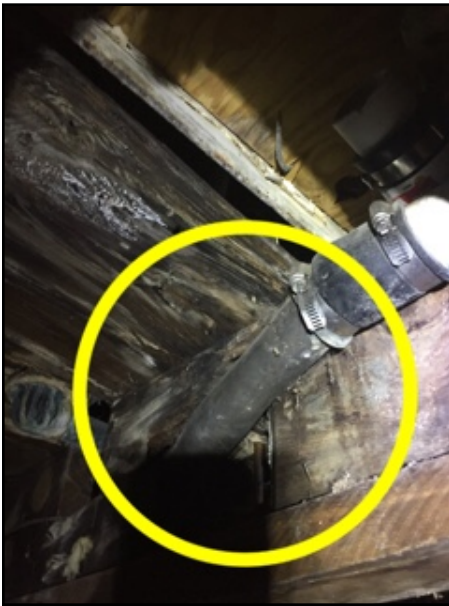
Figure 11-1

Comment 11:
Lead drain pipes should be replaced, they tend to crush in due to clamps.

11) Lead drain pipes should be replaced, they tend to crush in due to clamps.

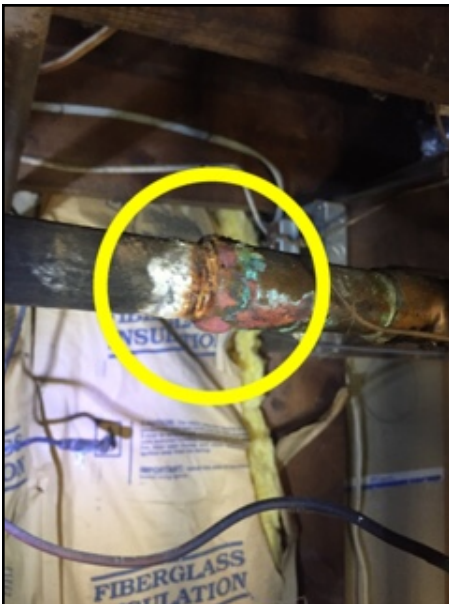
Figure 12-1

Comment 12:
Incorrect union of two different types of metal, needs a dielectric union put in which will stop the galvanic corrosion seen in this photo.

12) Incorrect union of two different types of metal, needs a dielectric union put in which will stop the galvanic corrosion seen in this photo.

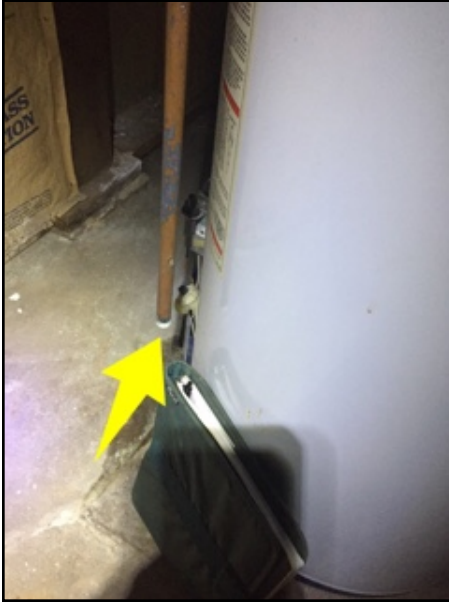
Figure 13-1

Water heater pressure relief valve extender should be no more than 6" from floor. Recommend correction by a plumber

13) Water heater pressure relief valve extender should be no more than 6" from floor. Recommend correction by a plumber

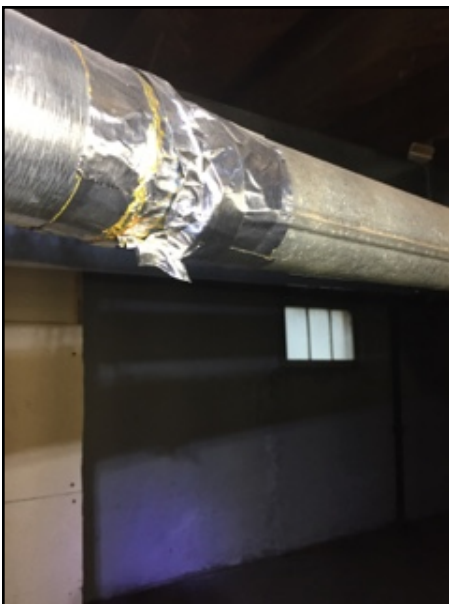
Figure 14-1

Water heater vent in improperly pitched and fastened together. Recommend correction by a plumber or HVAC contractor.

14) Water heater vent in improperly pitched and fastened together. Recommend correction by a plumber or HVAC contractor.

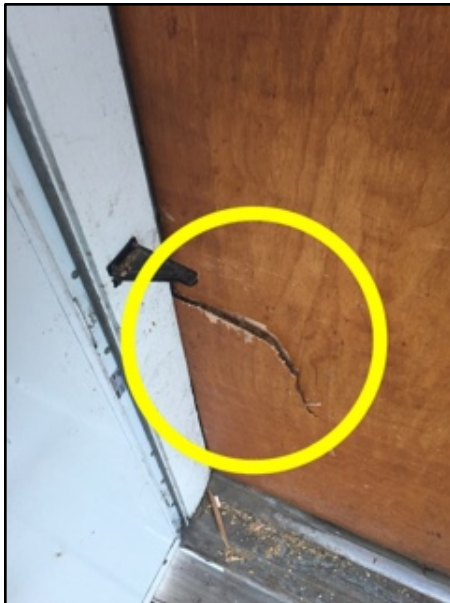
Figure 15-1

Comment 15:
Back entry door has been severely damaged .

15) Back entry door has been severely damaged .
