KC Realty Inspections

Home Inspection Report

54321 Any Street, Any Town, KS or MO 64101

Wednesday November 1, 2017

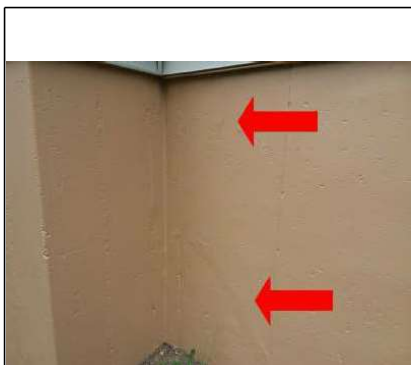
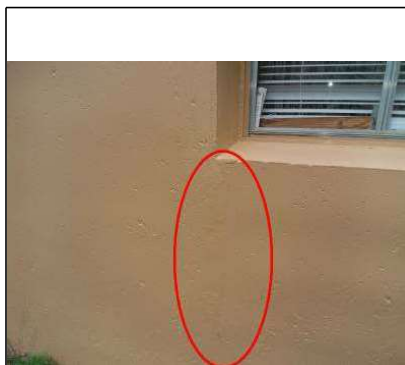
Exterior walls • **Monitor:** Common minor cracks were observed on the exterior walls of the house. This implies that structural movement has occurred. The location, size, shape of these cracks is common. The inspection did not find evidence of significant movement requiring immediate major repairs.

East exterior wall cracks

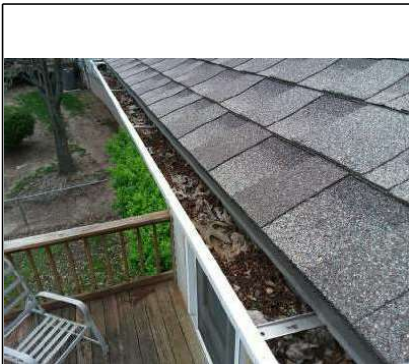
Gutters & downspouts • **Repair:** The gutters require cleaning to avoid spilling roof runoff around the building - a potential source of water entry or water damage.

Gutters are dirty

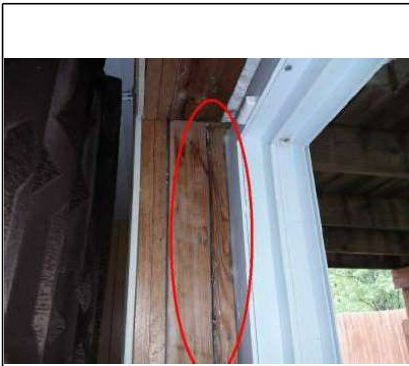
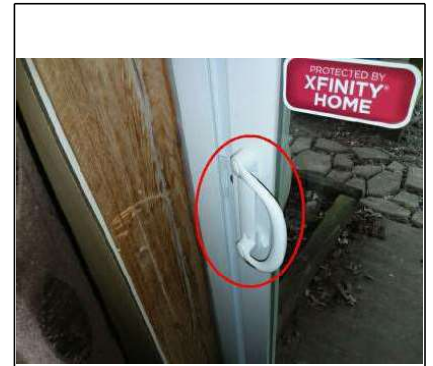
- Doors (Exterior)**
- **Repair** : The lower rear door jamb is damaged and/or split and needs repair.
 - **Repair**: The upper patio door weather strip is damaged and needs improvement.
 - **Repair**: The lower rear door locking hardware is damaged or needs adjustment to function properly.

Lower rear door

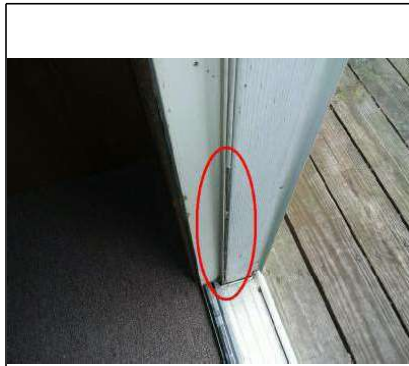
Upper patio door

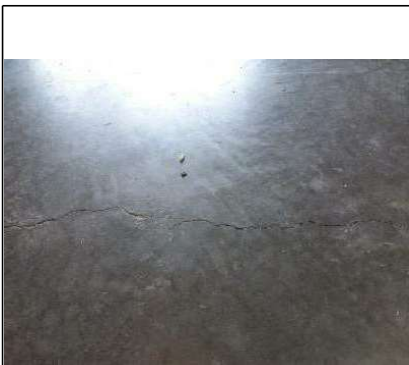
Garage floor cracks

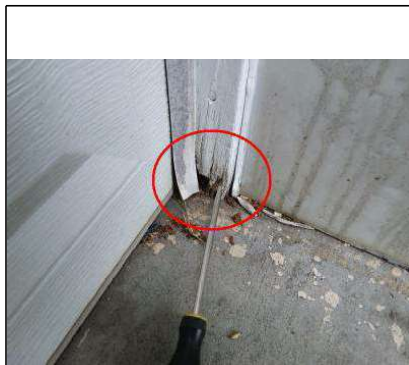
Garage frame wood rot

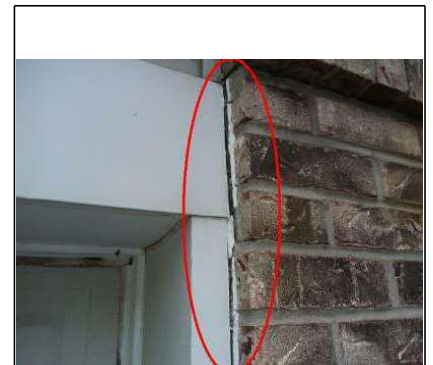
Caulk needed

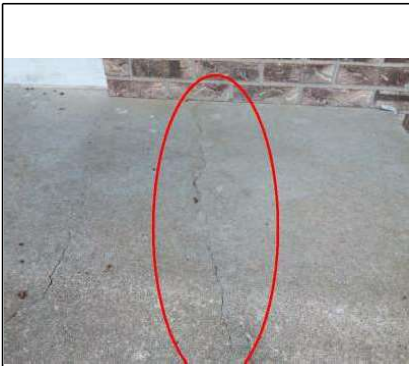
Typical cracks at porch

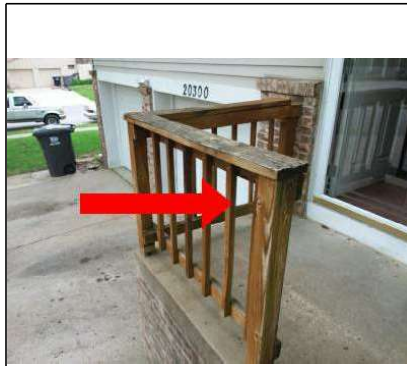
Porch railing loose

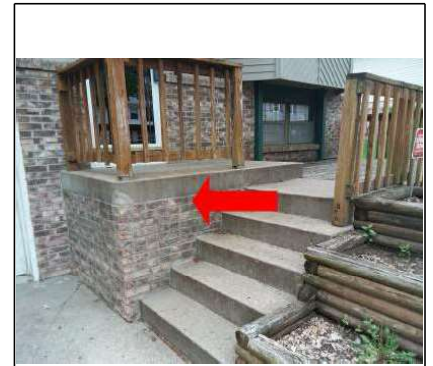
Porch railing needed

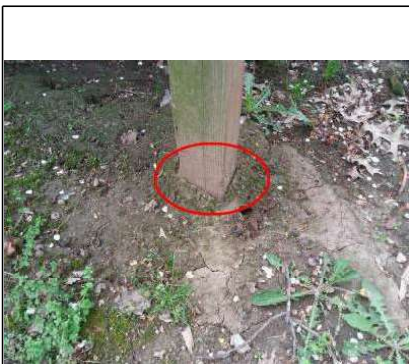
Deck post below soil

- **Monitor, Repair** : The deck is in need of power washing and painting or staining to prolong the life.
- **Monitor, Repair**: The support posts for the deck are below the soil. This configuration is prone to rot. Rising above soil level is recommended. The potential of rot could already be present.

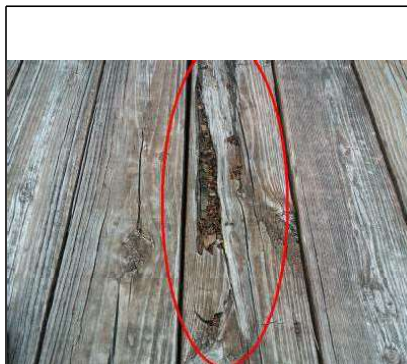
Wood rot at deck

- **Repair**: The deck shows evidence of rot. Replacement may eventually be desired. In the interim, localized repairs could be undertaken.
- **Repair, Safety Issue**: The deck railing and a few boards are loose and need repairs.

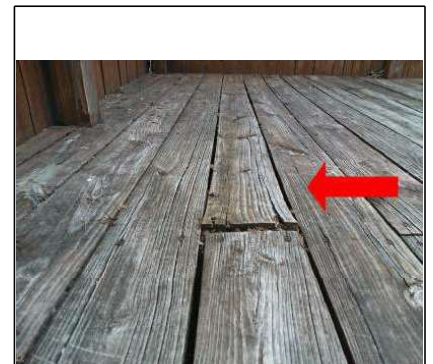
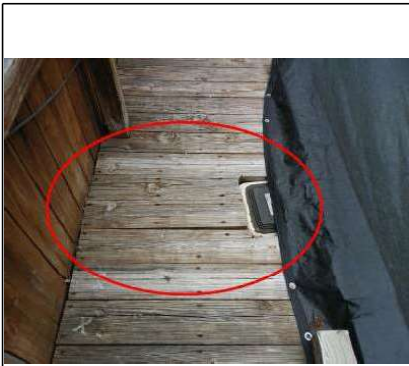
Loose boards at deck

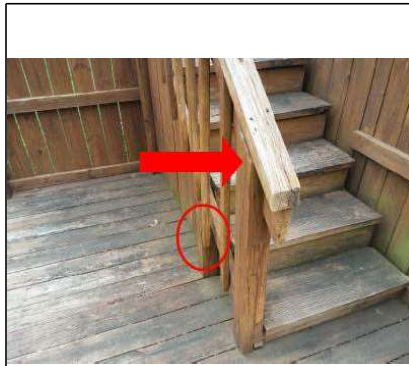
Loose railing and spindle

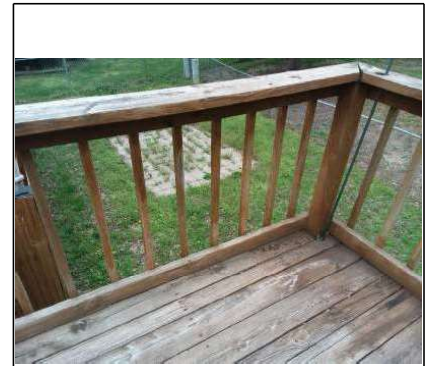
Large openings in railing

- **Repair, Safety Issue**: The openings in the deck railing are large enough to allow a child to fall through. It is recommended that this be corrected for improved child safety.

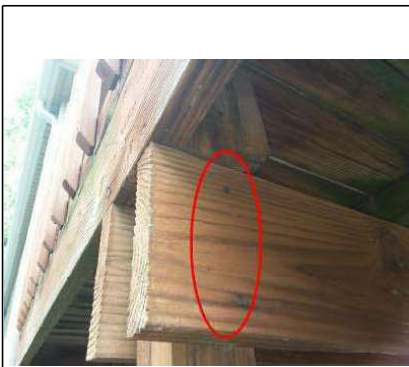
Deck beam through bolts needed

- **Repair**: The support beam for the deck requires "through bolts", bolts that go through the beam and post and are secured with nuts, to ensure the beam doesn't pull away from the post. These through bolts are needed at all posts that are holding the beam.

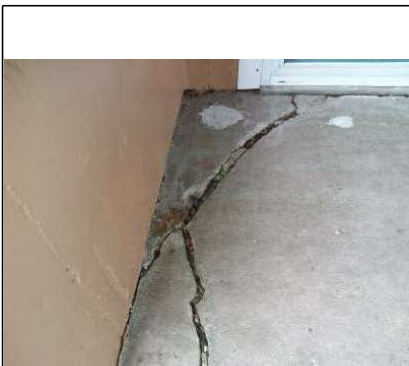
- **Monitor, Repair:** The patio has settled and/or heaved resulting in moderate cracking.

Patio cracks

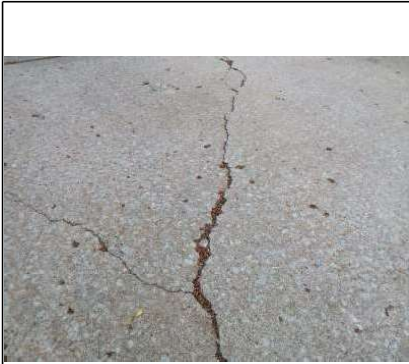
- **Monitor:** The driveway has settled resulting in typical cracks.

Driveway cracks

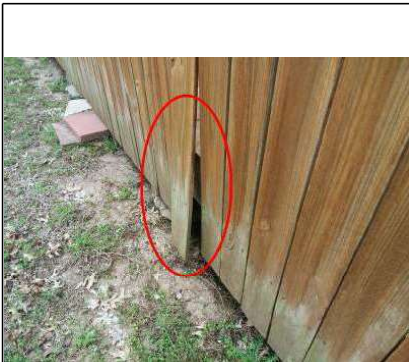
- **Monitor, Repair:** The fence is in need of minor repairs.

Loose board at pool fence

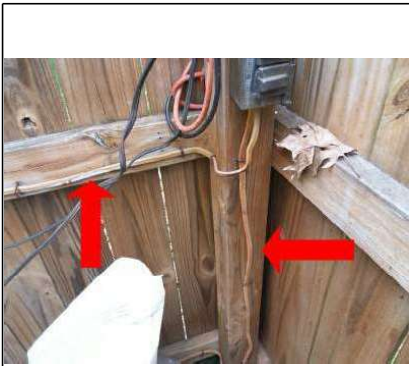
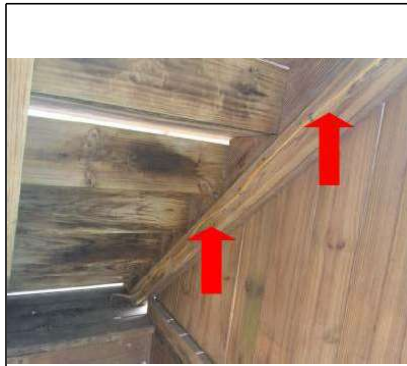
Exposed wiring

Distribution wires • **Repair:** Wiring exposed on the deck should be relocated or protected by a rigid conduit.

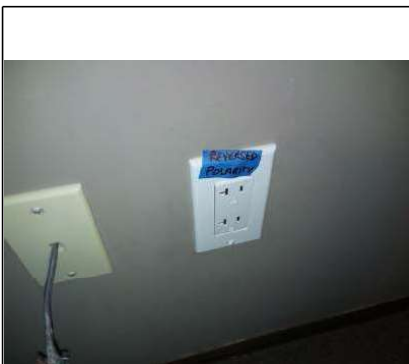
Dining room

- **Repair:** An outlet marked with blue tape in the dining room has reversed polarity (i.e. it is wired backwards). This outlet and the circuit should be investigated and repaired as necessary.

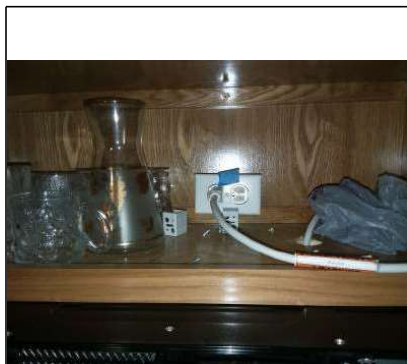
Above microwave

- **Repair:** An ungrounded 3-prong outlet above the microwave should be repaired. In some cases a ground wire may be present in the electrical box and simply needs to be connected. If no ground is present "repair" can be as simple as filling the ground slot with epoxy. Better, since having a ground increases safety, a grounded circuit could be strung to this outlet, or a separate ground wire could be connected. Some electrical codes allow the installation of a ground fault circuit interrupter (GFCI) type outlet where grounding is not provided. In this case the GFCI may work but can't be tested by normal means.

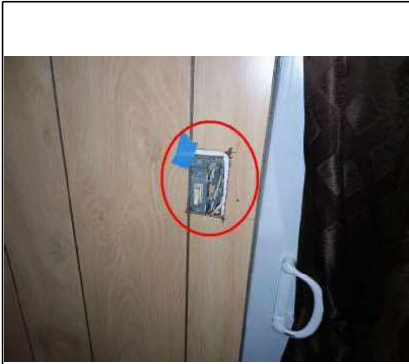
Basement

- **Repair:** Switch cover(s) missing in the basement. Repair is needed to avoid shock hazard.

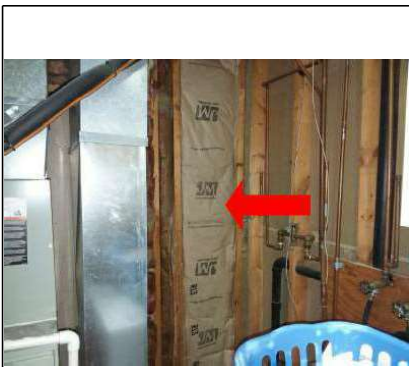
- Basement**
- **Monitor** : Insulation with exposed Kraft paper vapor barrier was observed. Most cities adopted the National Fire and Safety codes in 2009 that requires wall insulation with Kraft paper vapor barrier in the basement, furnace room and garage to be covered with a fire rated drywall. Since this house was built prior to this time and the code did not exist it is grandfathered and bringing up to code is not required. However, if there are plans to finish areas with Kraft paper vapor barrier the proper fire rated drywall should be installed.

Kraft paper vapor barrier

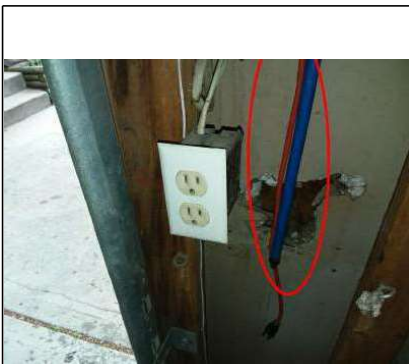
Supply • **Monitor:** Supply piping may be susceptible to freezing during extremely cold weather. Heating or insulating this pipe would be wise.

Front hose bib supply line

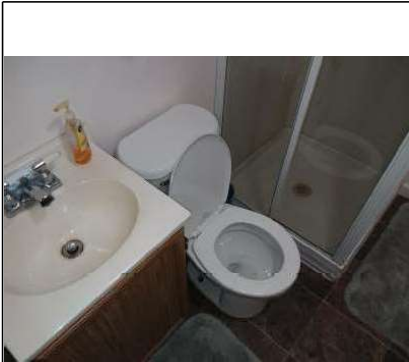
Loose toilet in basement

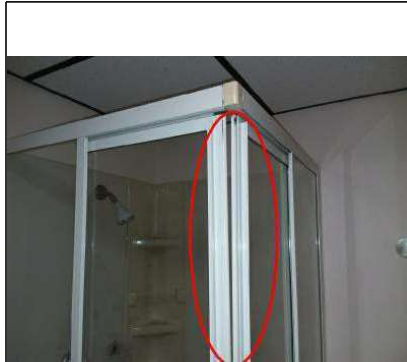
Basement shower doors

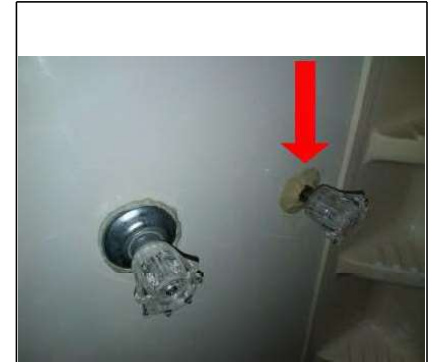
Missing flange

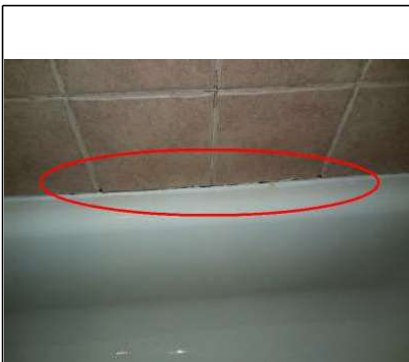
Cracked caulk

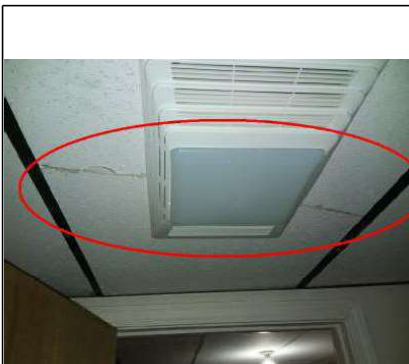
Basement bathroom ceiling

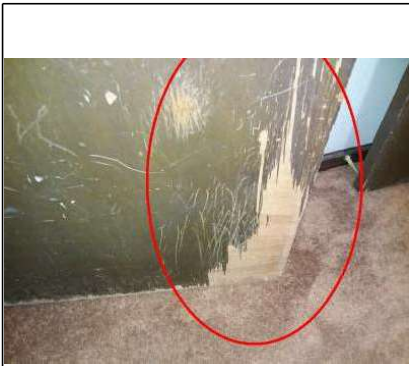
Damage on interior garage door

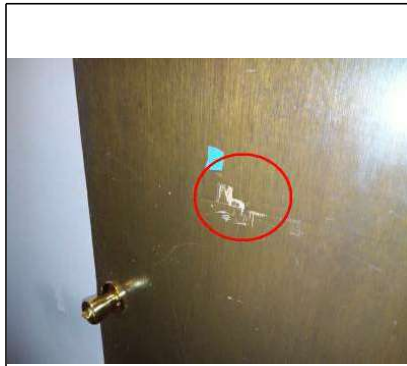
Damage on basement door

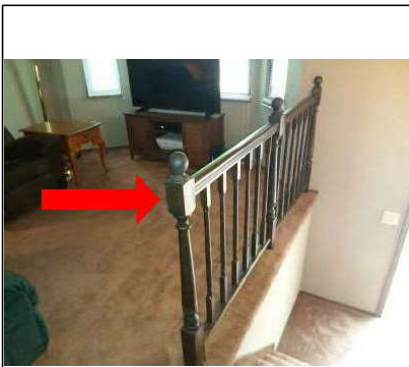
Loose railing

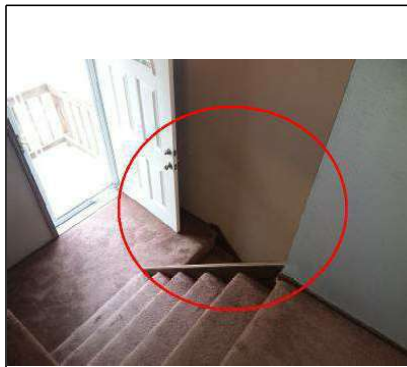
Railing needed

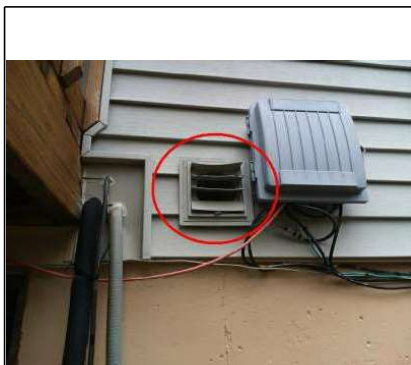
Clothes dryer unit • **Monitor, Repair:** The dryer vent louvers are stuck open, this is possibly indicating that the vent needs to be cleaned.

Dryer vent
