KC Realty Inspections

Home Inspection Report

**123 Some Street
Anytown, US 12345**

Inspected on Fri, Mar 24 2017 at 12:45 PM

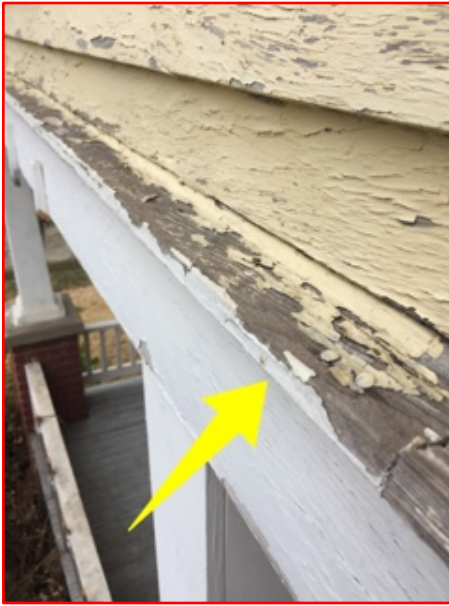
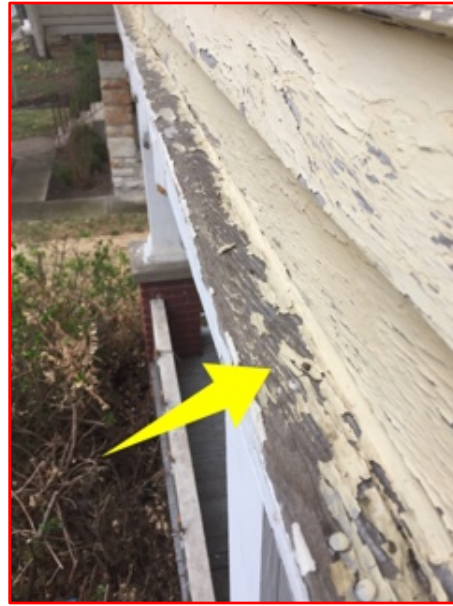
1) Ledger board above porch needs drip cap.

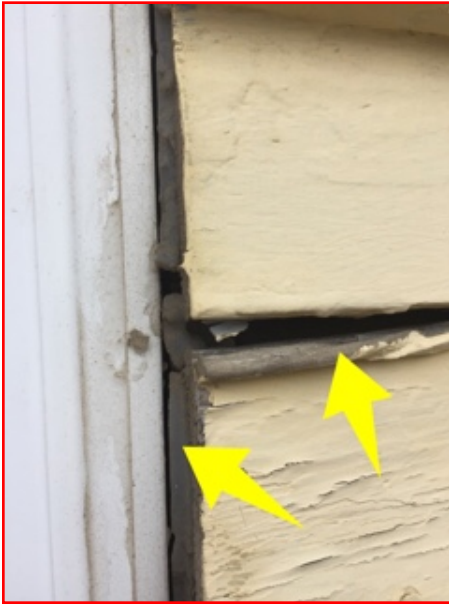
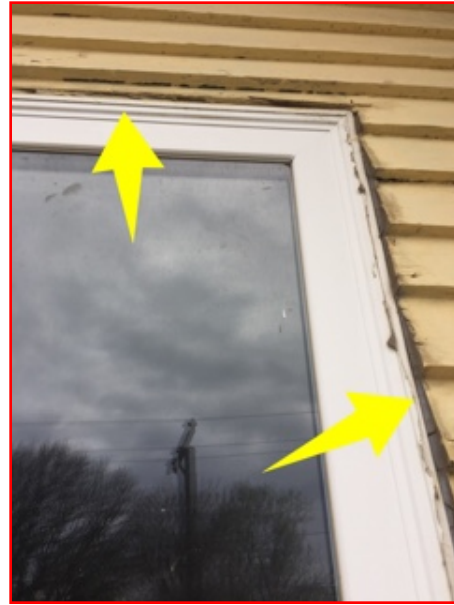
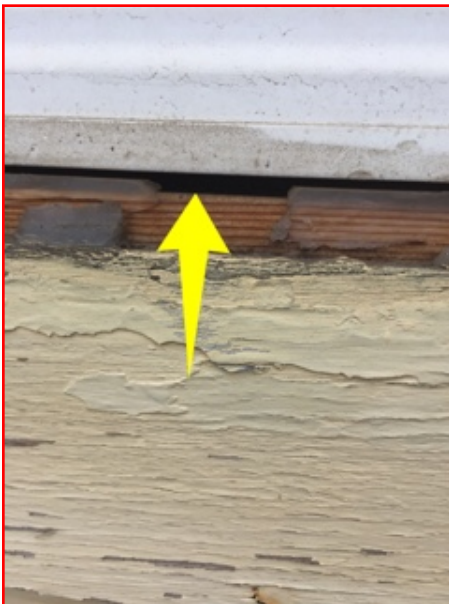
Comment 2:
Window and siding around window in front of house needs to be caulked and sealed. Recommend adding additional trim, drip cap and J-channel around and above window

2) Window and siding around window in front of house needs to be caulked and sealed. Recommend adding additional trim, drip cap and J-channel around and above window

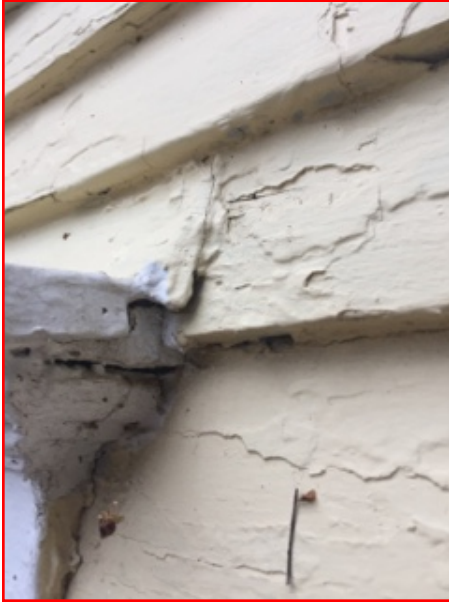
Figure 4-1

Comment 4:
Drip cap above window in back of house should be monitored for bad seal. Drip cap should be behind siding to keep moisture out. Caulk is loose and needs to be replaced.

4) Drip cap above window in back of house should be monitored for bad seal. Drip cap should be behind siding to keep moisture out. Caulk is loose and needs to be replaced.

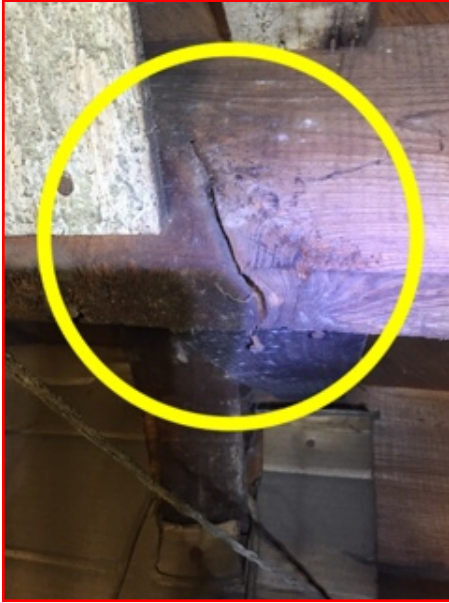
Figure 6-1

Comment 6:
Broken floor joist. Recommend repair by a carpenter

6) Broken floor joist. Recommend repair by a carpenter

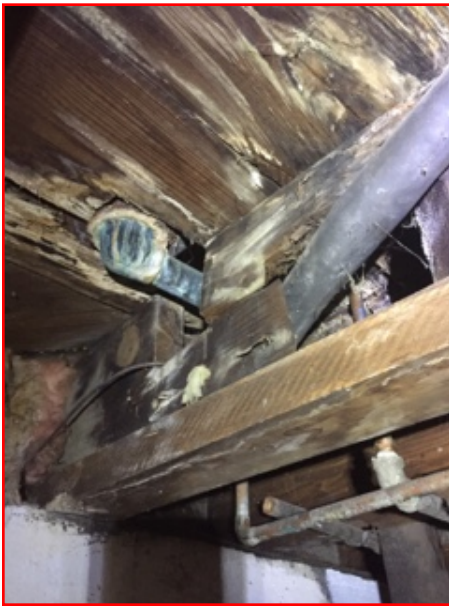
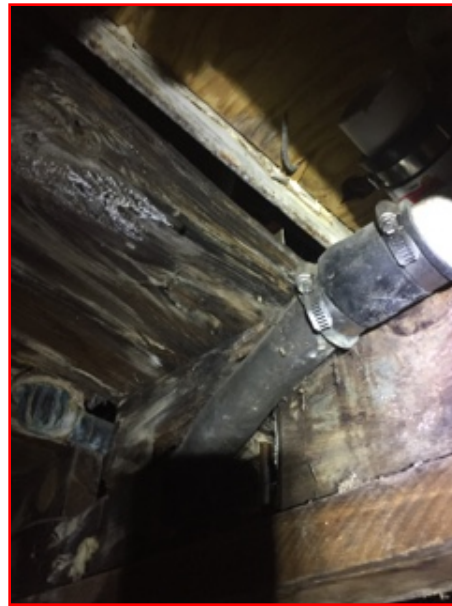
Comment 7:
Moisture damaged subfloor below first floor bathroom. Recommend repair by a carpenter.

7) Moisture damaged subfloor below first floor bathroom. Recommend repair by a carpenter.

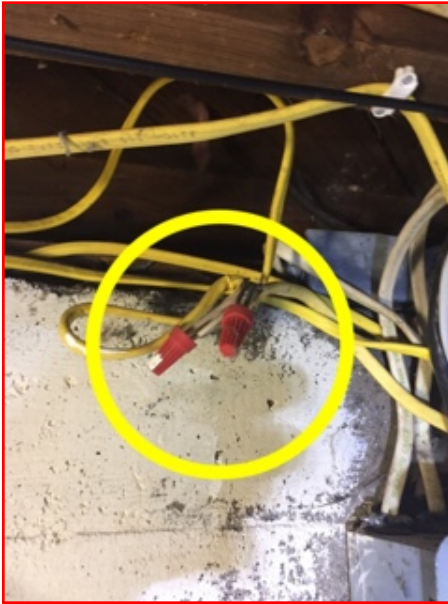
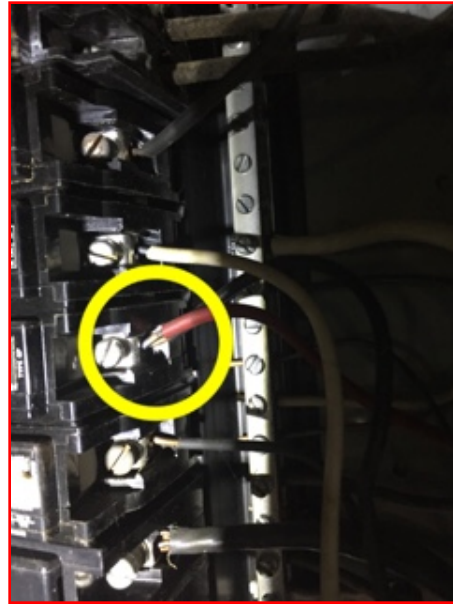
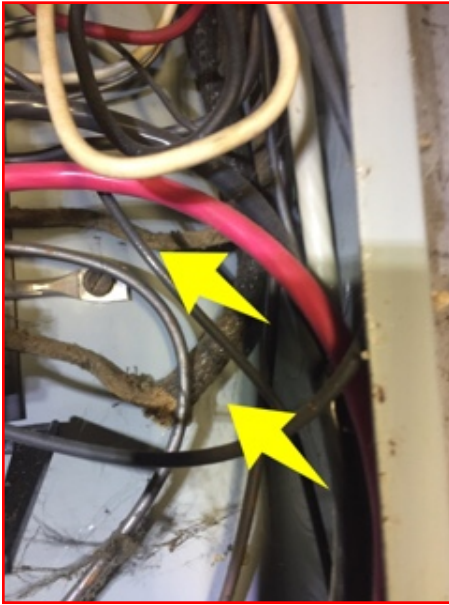
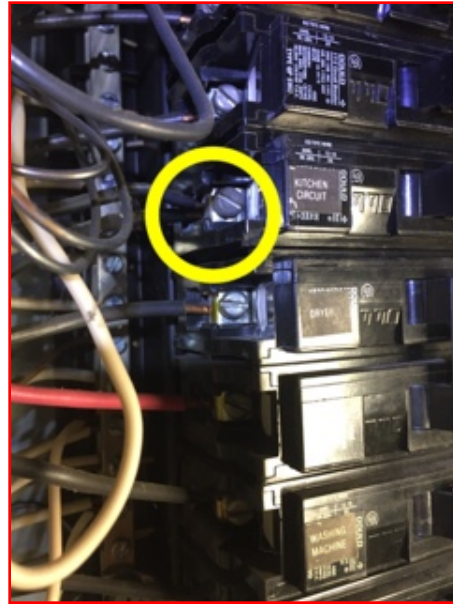
**Comment 8:**
Main overcurrent protection cut and not attached to main plumbing supply.
Recommend immediate correction

There are multiple double taps in electric panel. Double tapped wiring is dangerous.

There is old knob and tube wiring. Knob and tube wiring is out of date and should be changed.

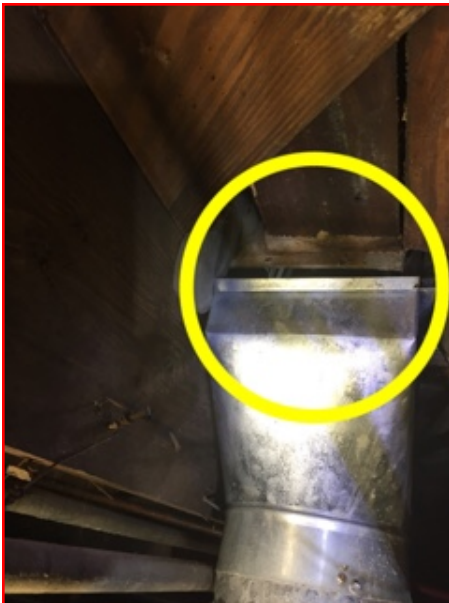
Figure 10-1

Vent not connected properly resulting in heat loss. Recommend securing vent properly

10) Vent not connected properly resulting in heat loss. Recommend securing vent properly

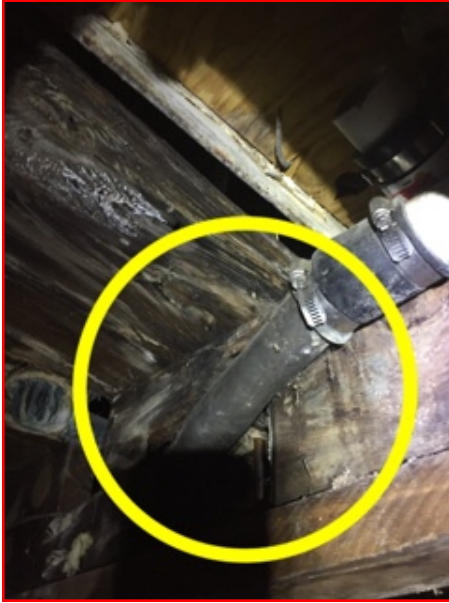
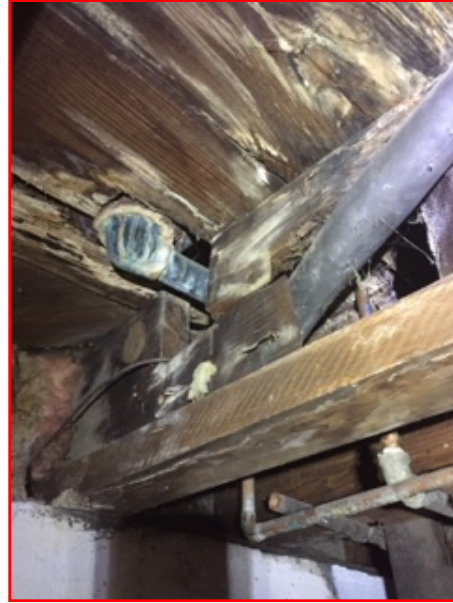
Comment 11:
Lead drain pipes should be replaced, they tend to crush in due to clamps.

11) Lead drain pipes should be replaced, they tend to crush in due to clamps.

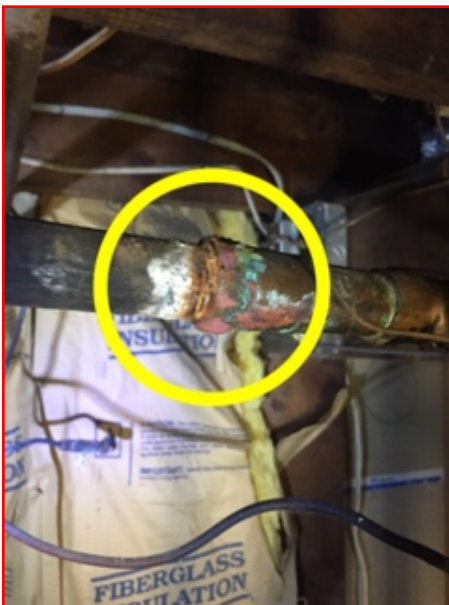
Figure 12-1

Comment 12:
Incorrect union of two different types of metal, needs a dielectric union put in which will stop the galvanic corrosion seen in this photo.

12) Incorrect union of two different types of metal, needs a dielectric union put in which will stop the galvanic corrosion seen in this photo.

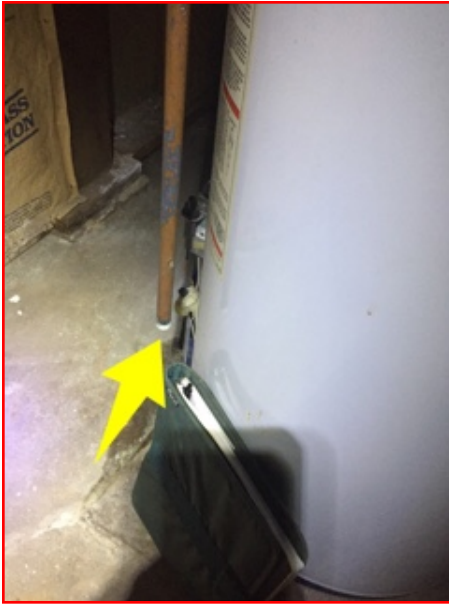
Figure 13-1

Water heater pressure relief valve extender should be no more than 6" from floor. Recommend correction by a plumber

13) Water heater pressure relief valve extender should be no more than 6" from floor. Recommend correction by a plumber

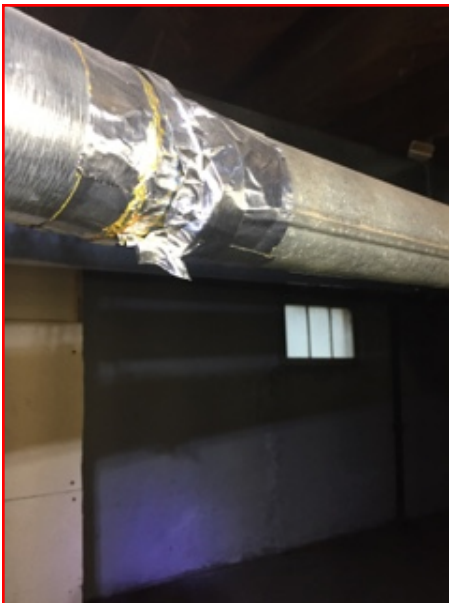
Figure 14-1

Water heater vent in improperly pitched and fastened together. Recommend correction by a plumber or HVAC contractor.

14) Water heater vent in improperly pitched and fastened together. Recommend correction by a plumber or HVAC contractor.

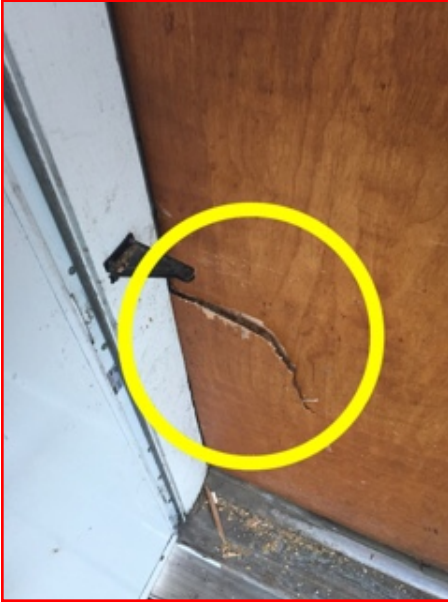
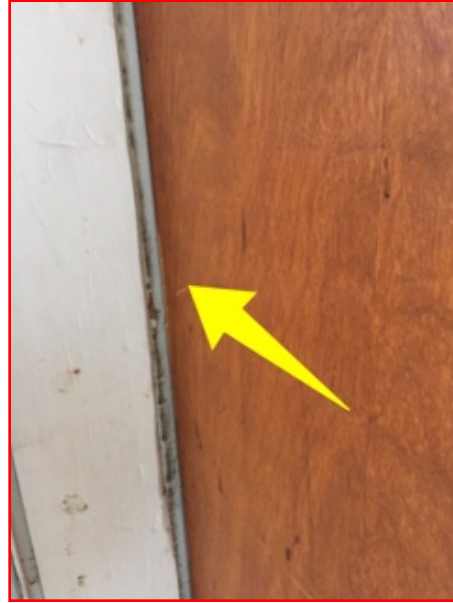
Comment 15:
Back entry door has been severely damaged .

15) Back entry door has been severely damaged .
